Structural Performance of Traditional Timber Structures in Japan against Seismic Load

Kaori Fujita

Department of Architecture, Graduate School of Engineering,
The University of Tokyo

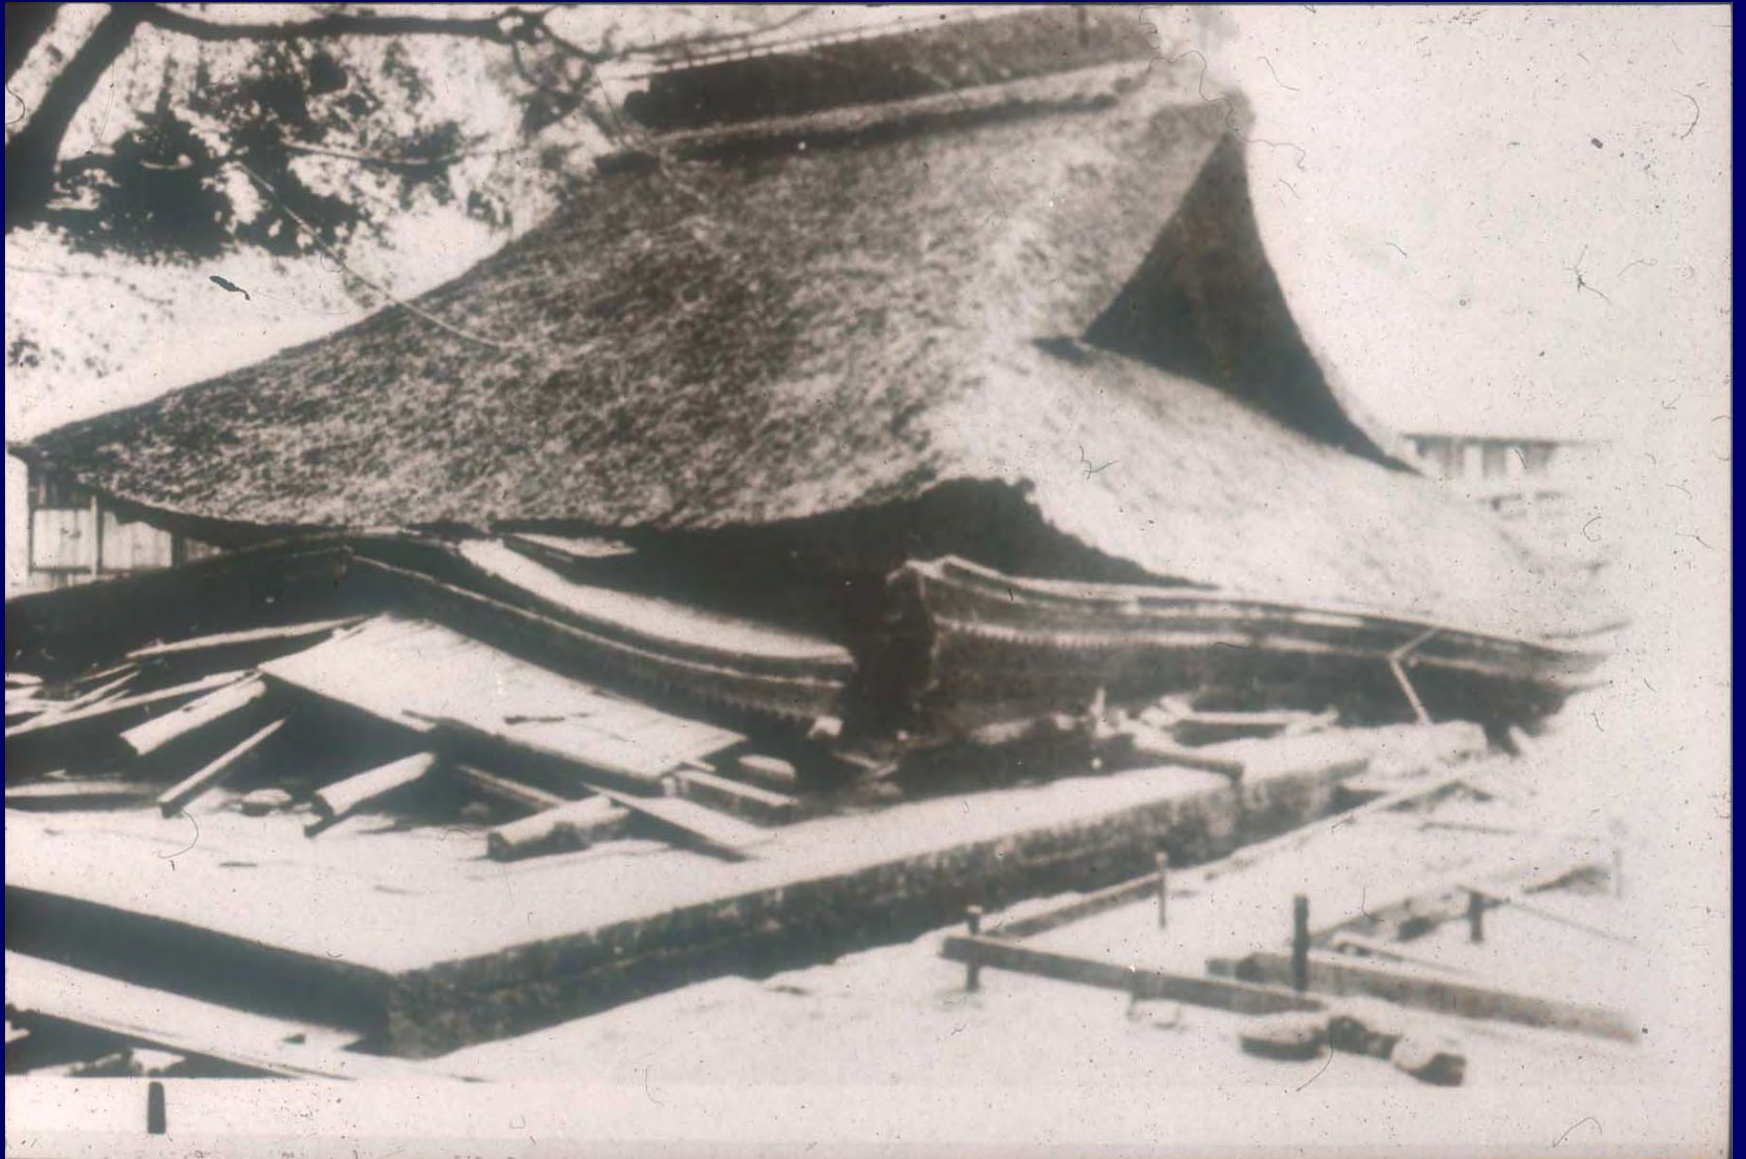
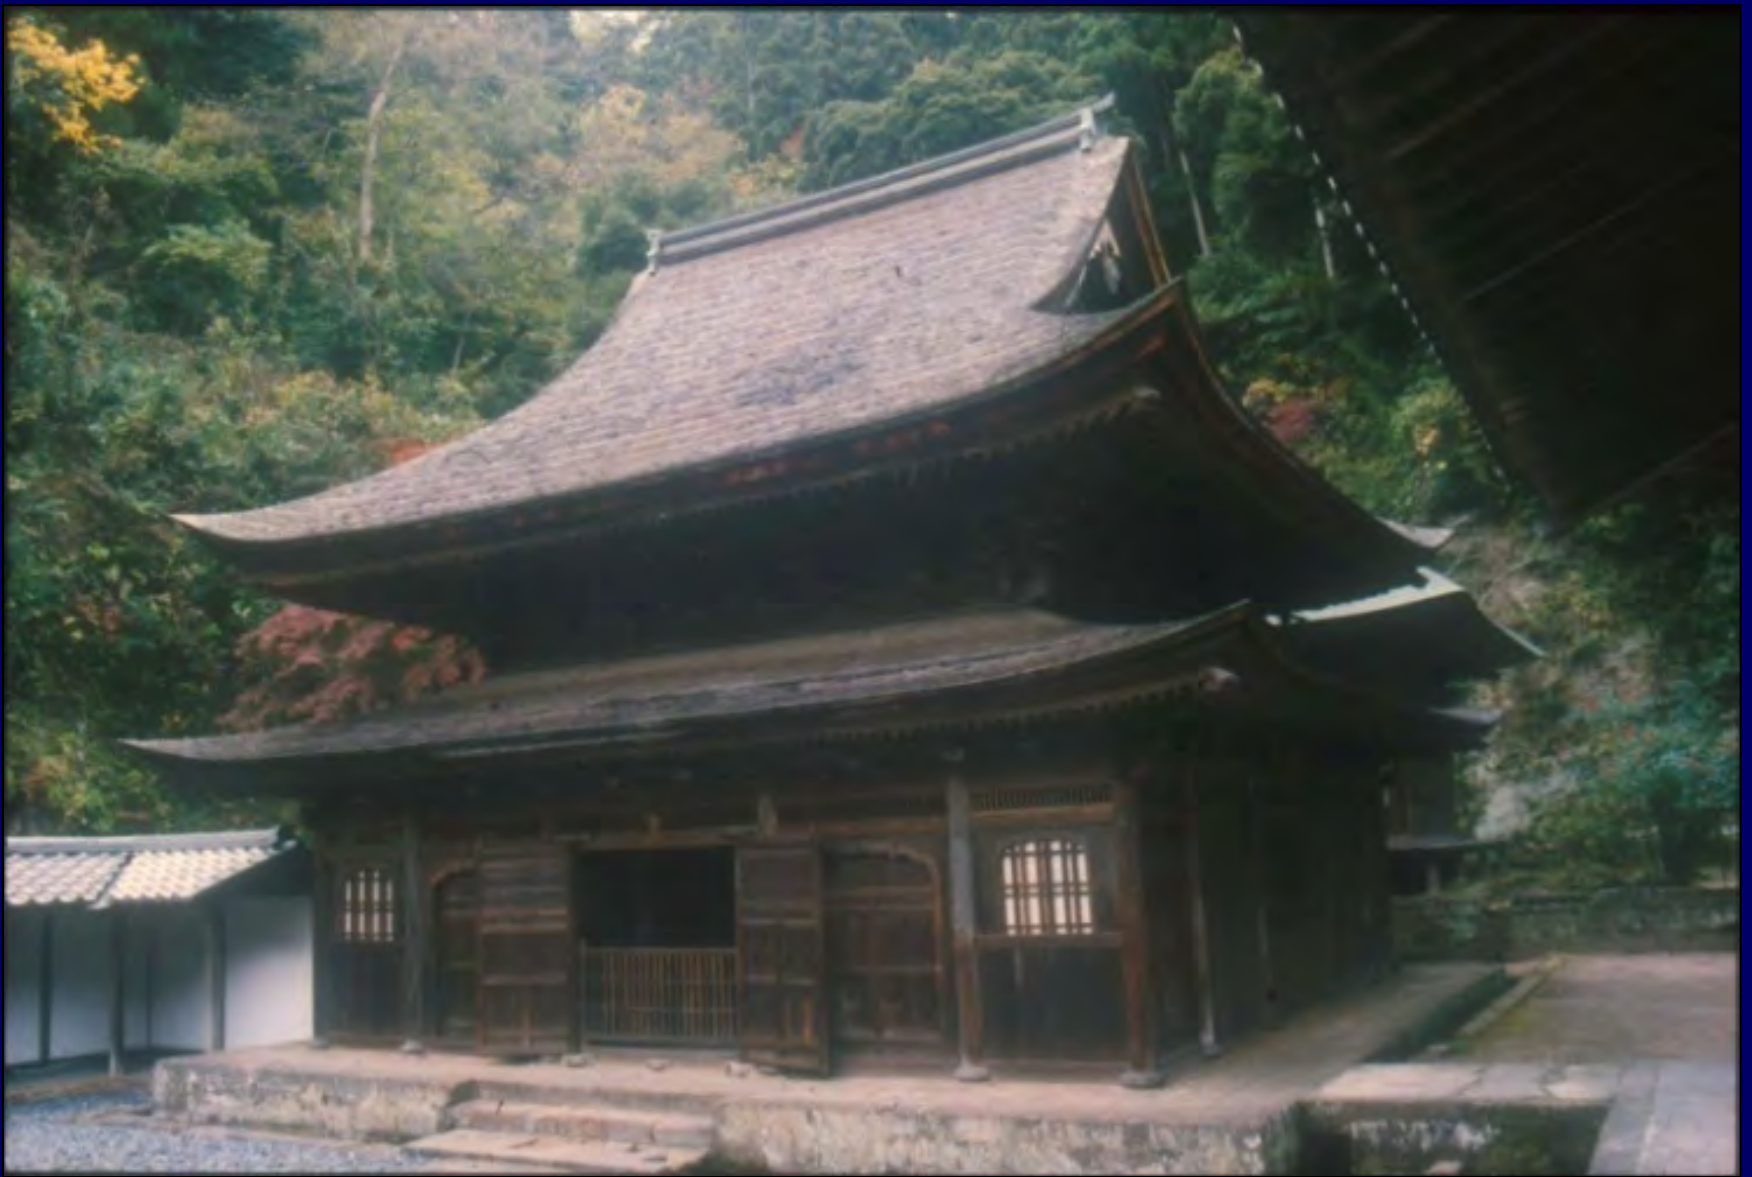
Engaku-ji Shariden restored after the earthquake
(Photo by Prof. Sakamoto)

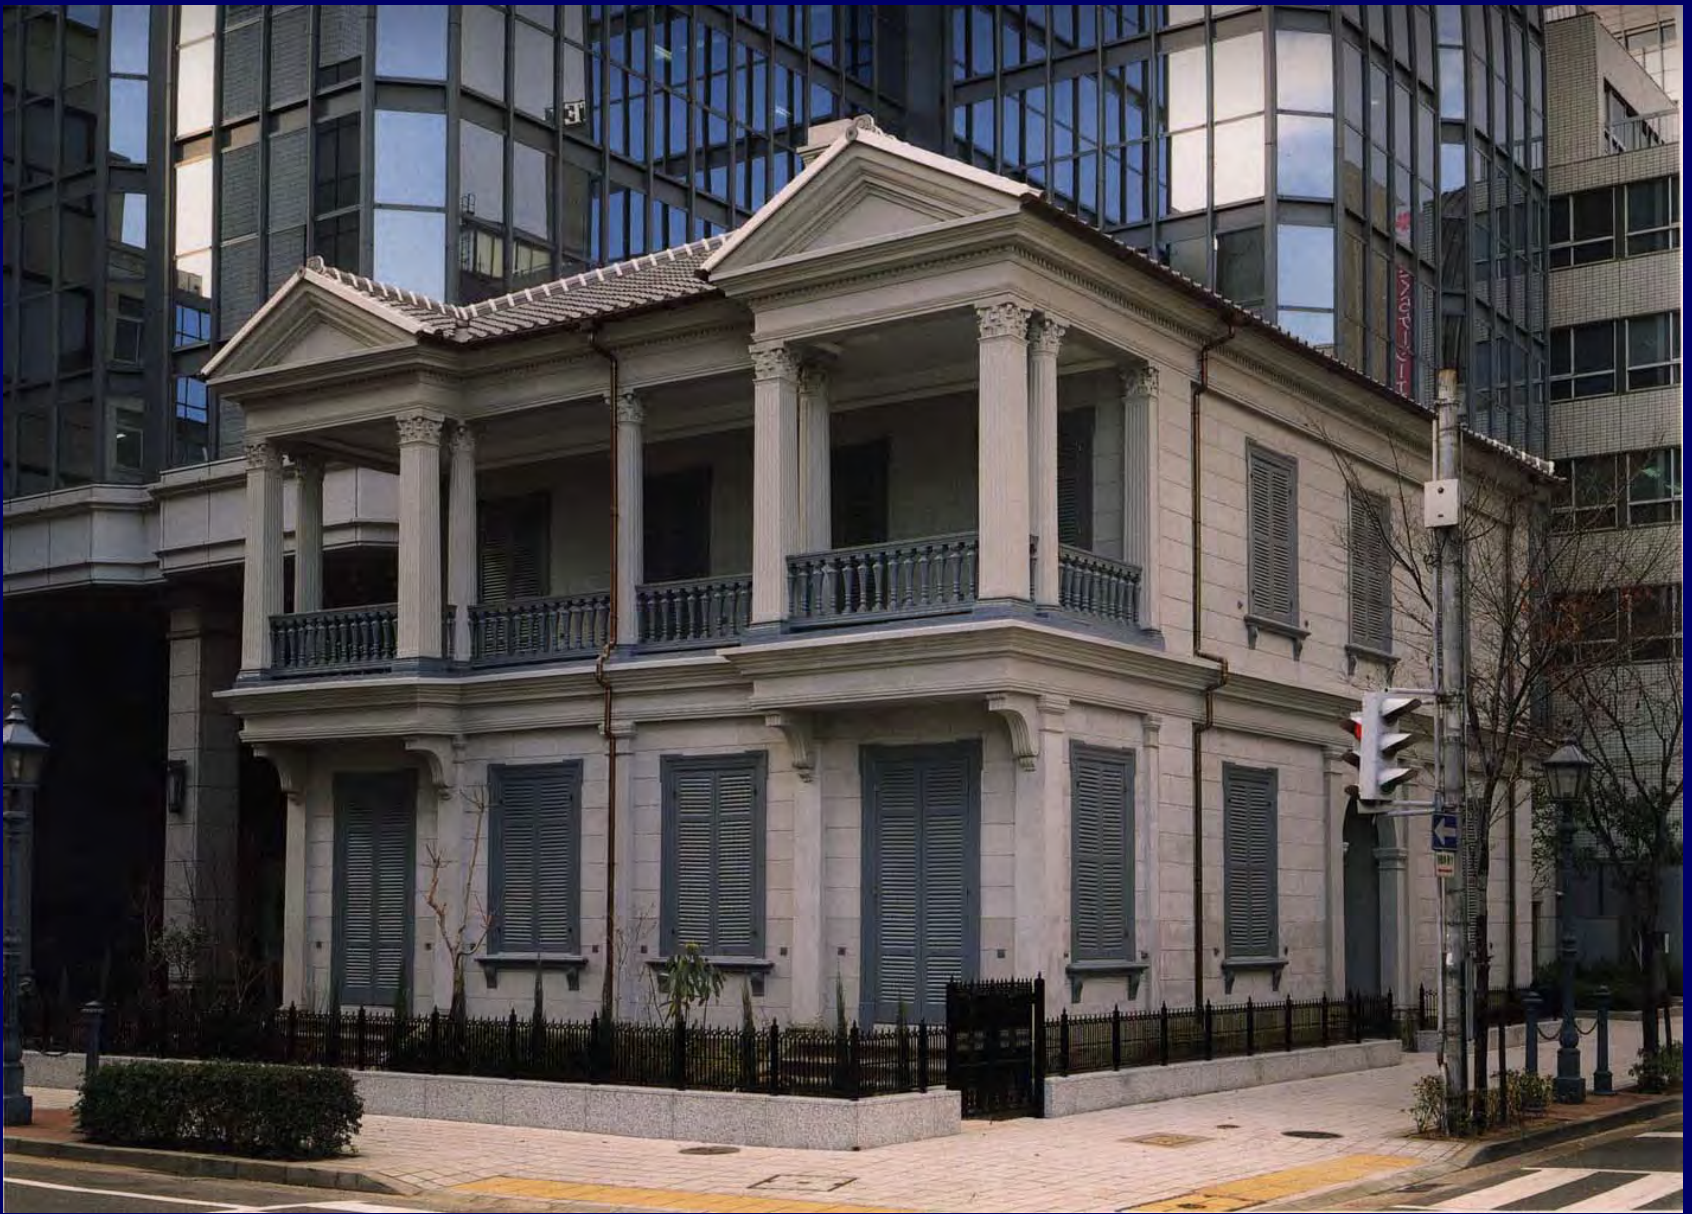
- Former Trading House on Lot.15 (1881)

Former Trading House
on Lot.15 destroyed by
the 1995 Hyogoken
nanbu earthquake
(Kobe)

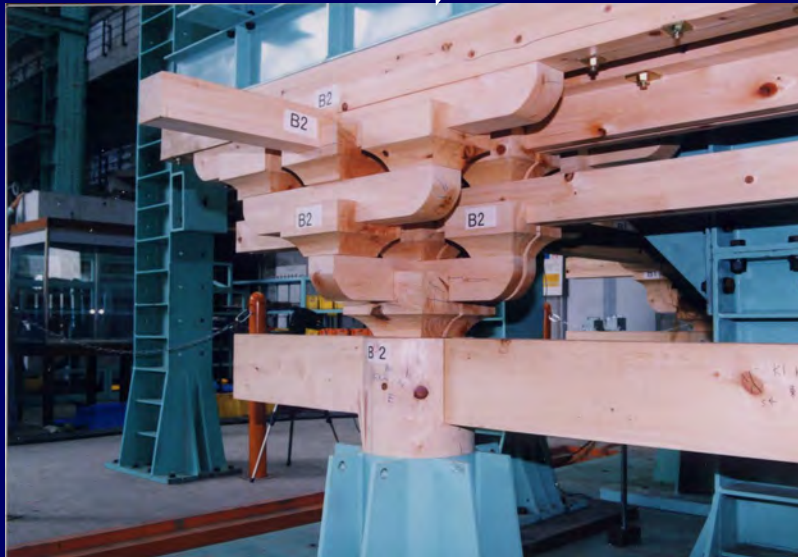
Bracket complex

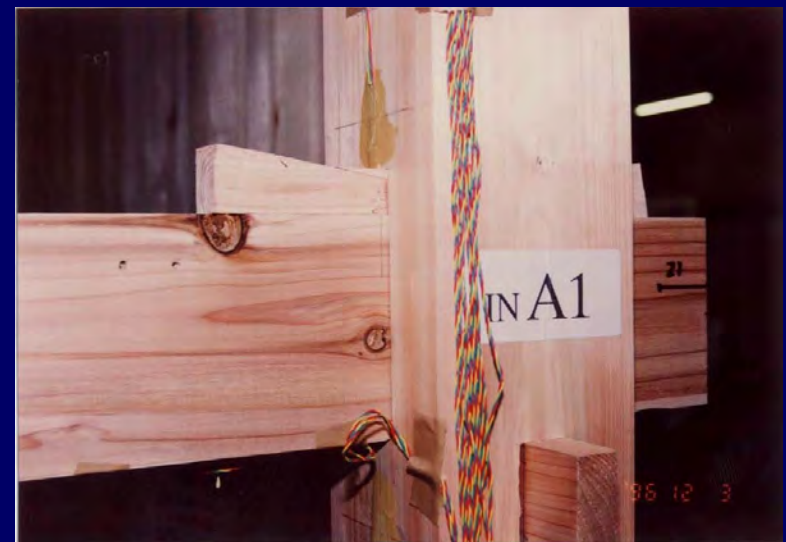
Frame with moment resisting joints

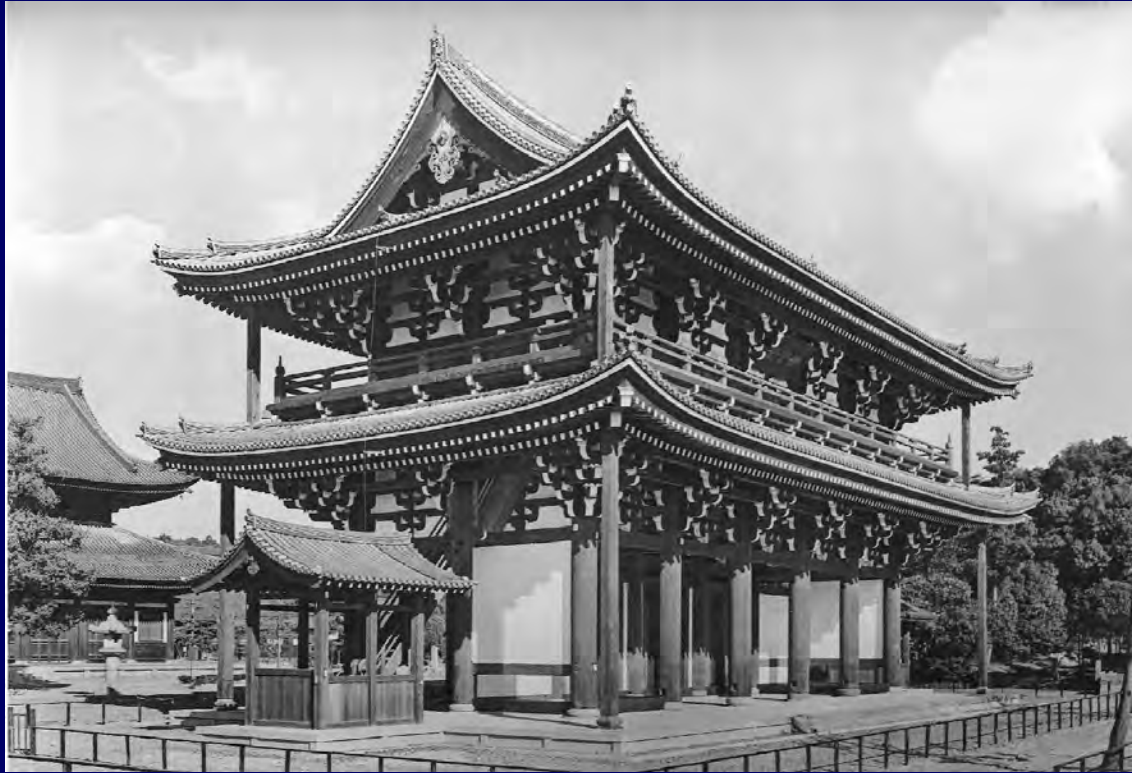
Tofuku-ji Temple Gate 15c

- Shear wall
- Joint
- Column
- Bracket complex

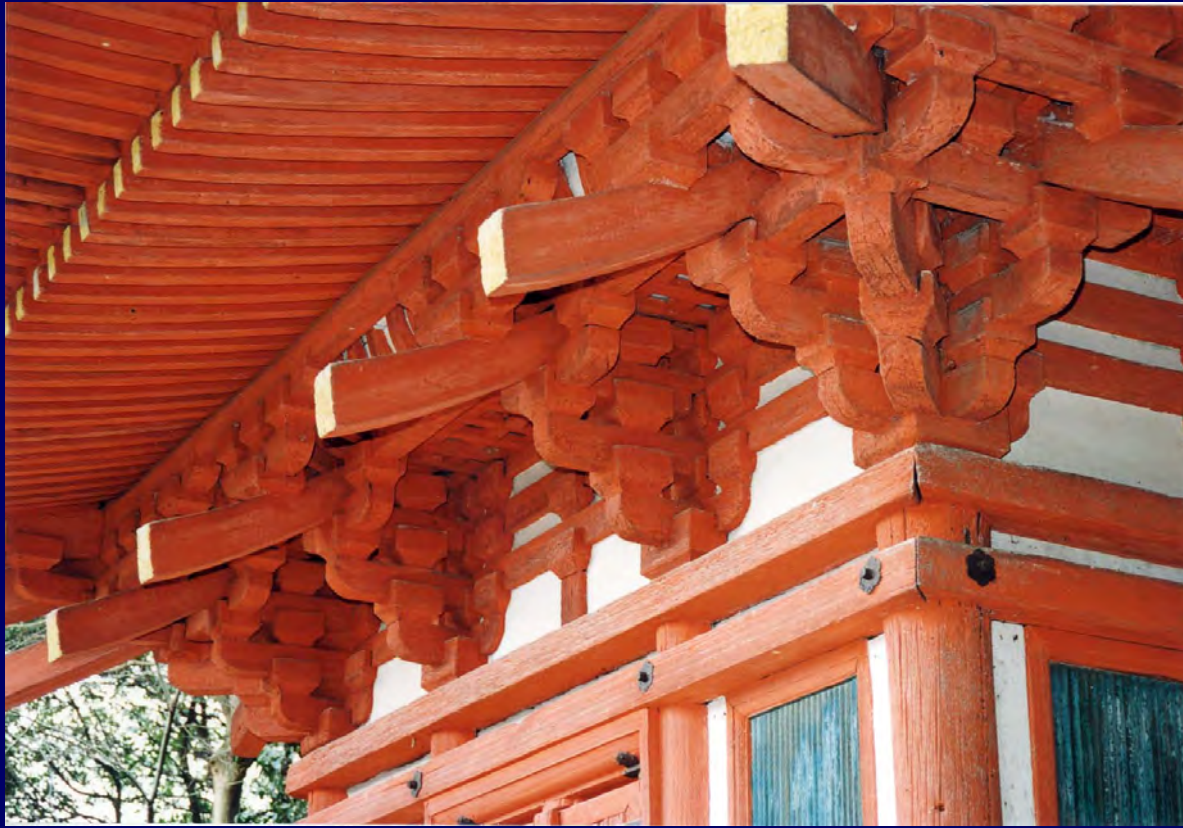
Piled (stacked) blocks of timber elements
Connection: timber dowel
wood work joints
friction

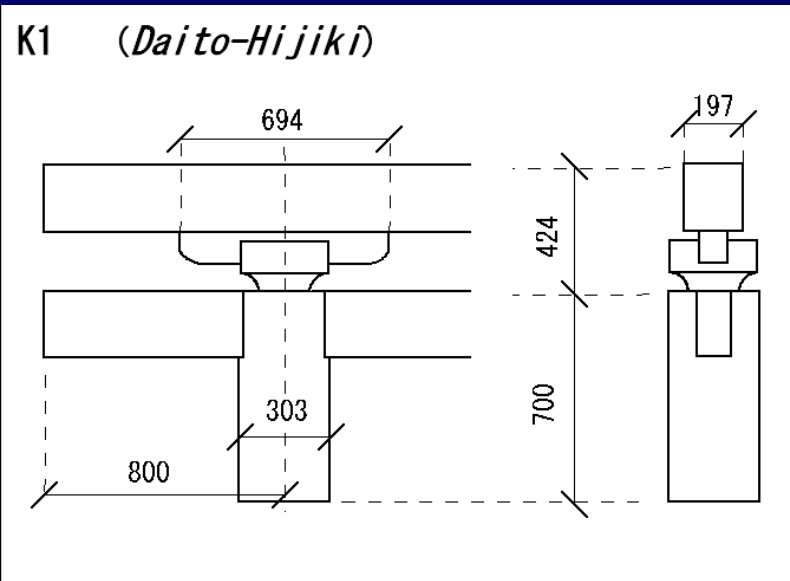
Specimen

Full scale models of 4 types of fundamental bracket complex

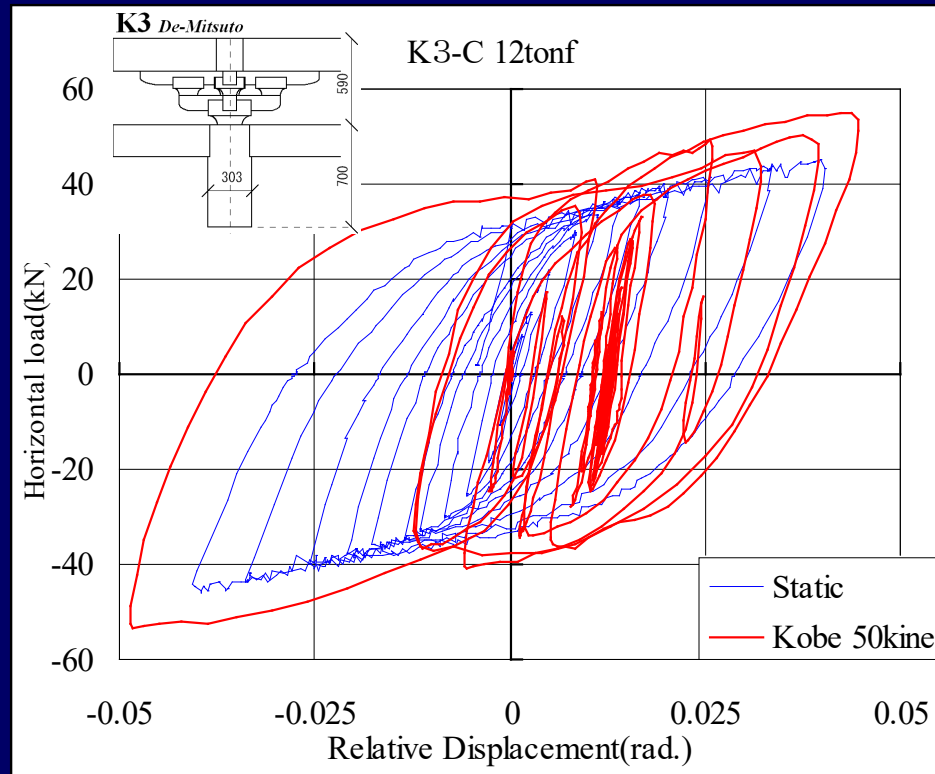
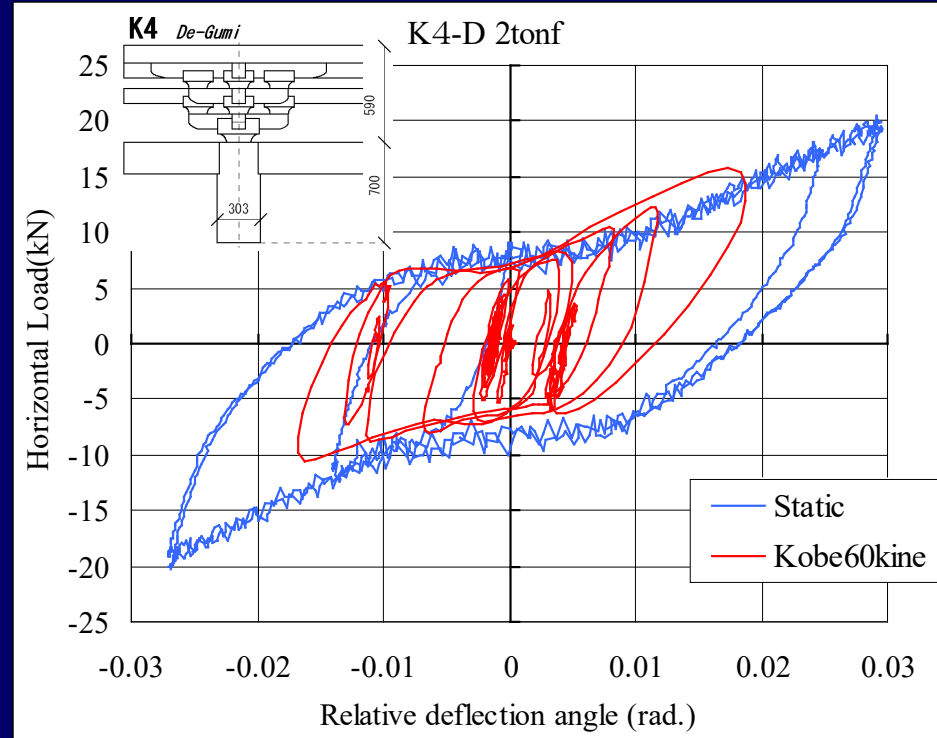
Performance of bracket complex by Static- Dynamic tests

Large energy dissipation by sliding and crushing of timber

Stiffness degradation can not be seen by multiple cyclic loading

Consistency in the deformation characteristic

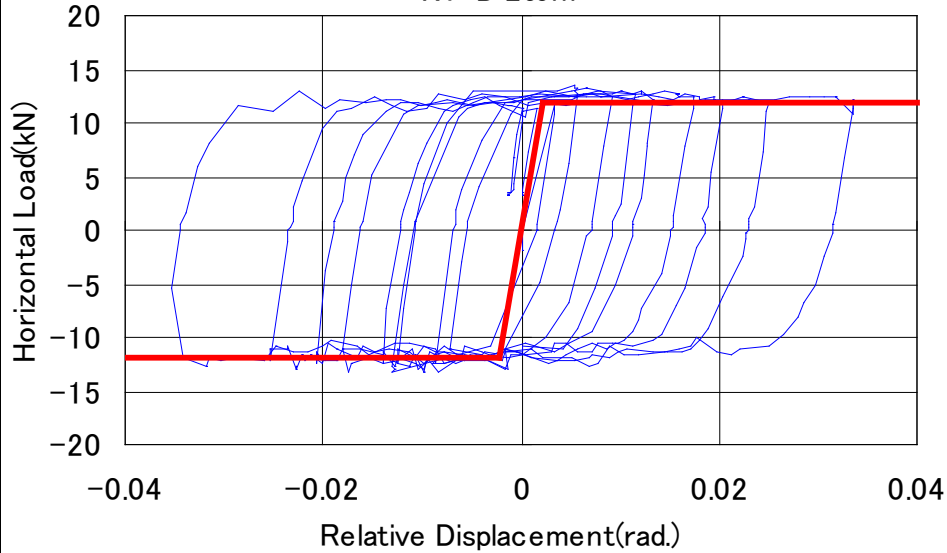
K1-D 2tonf

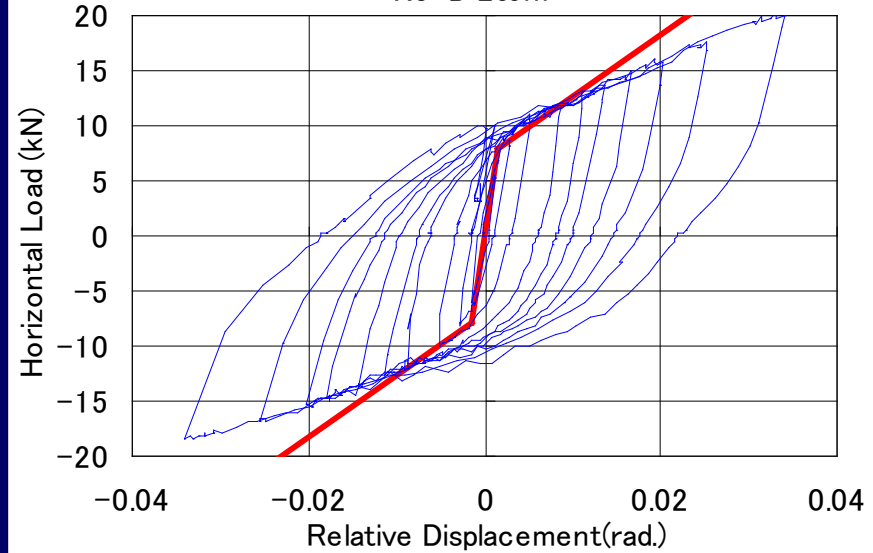
K3-D 2tonf

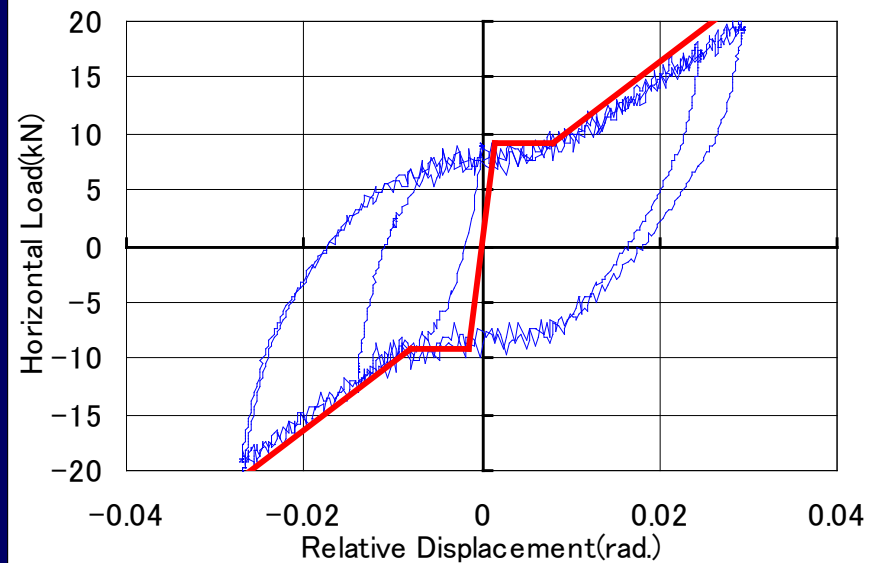
K4-D 2tonf

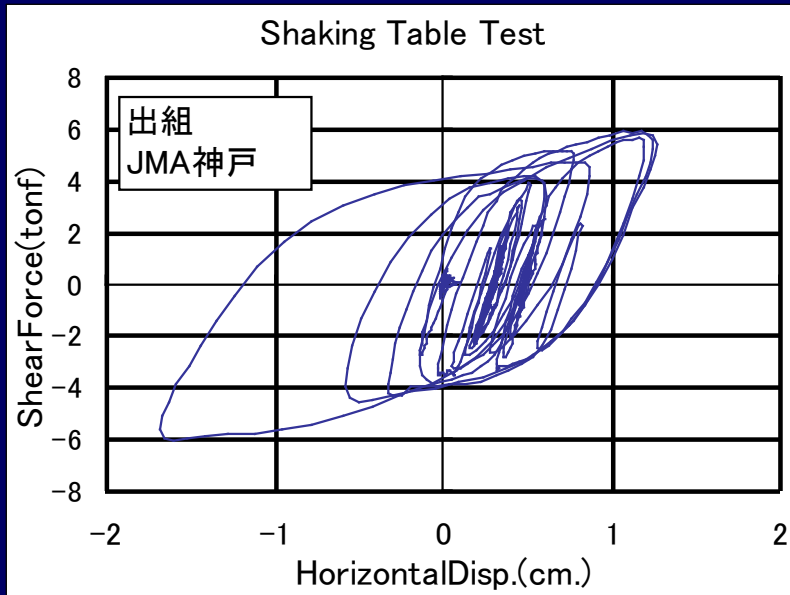
Non-linear analysis and shaking table test

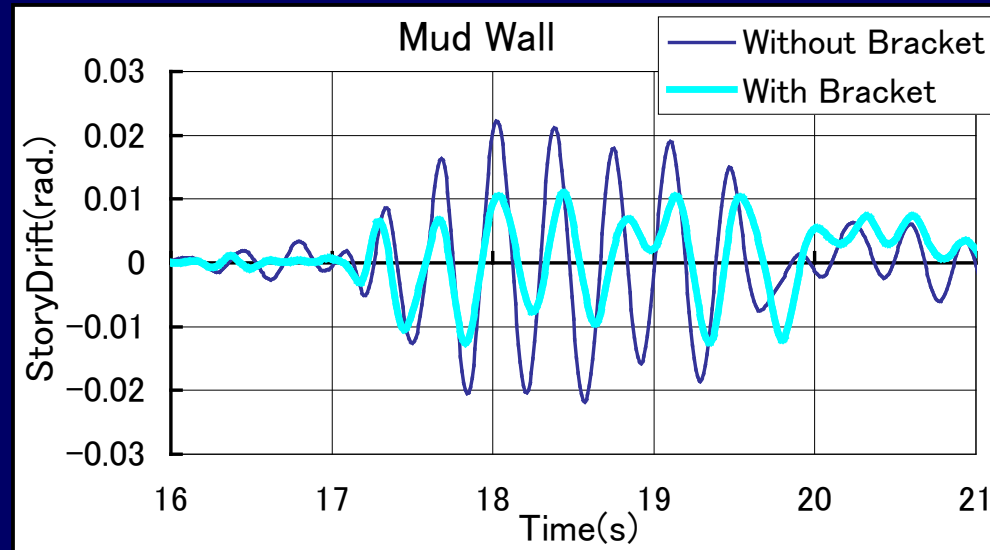
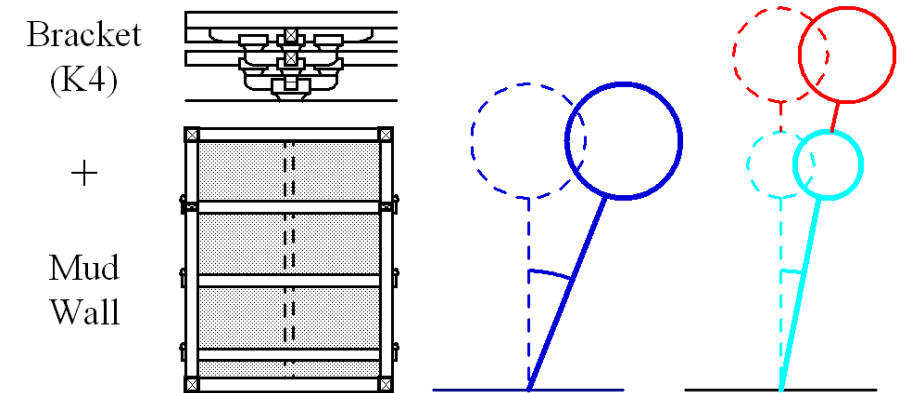
Simulated Effect on Total Structure

- Deformation of the structure can be expected to reduce by using the bracket
- If the stiffness is close

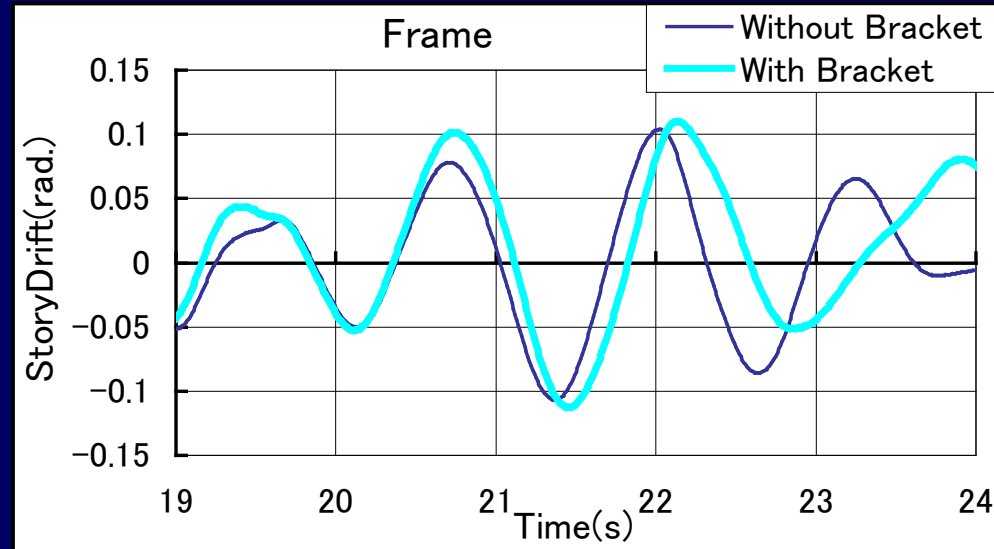
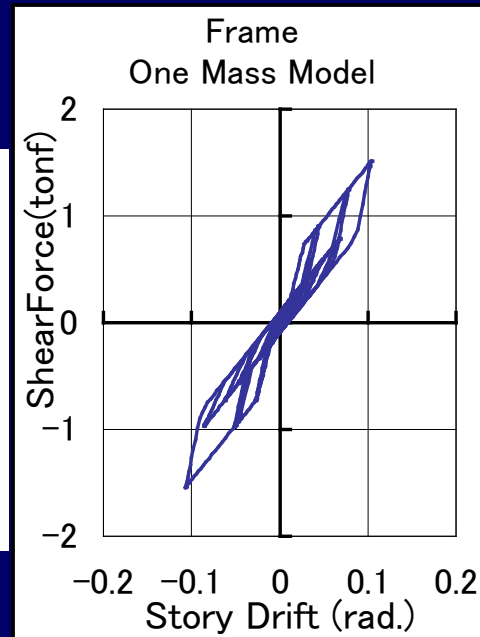
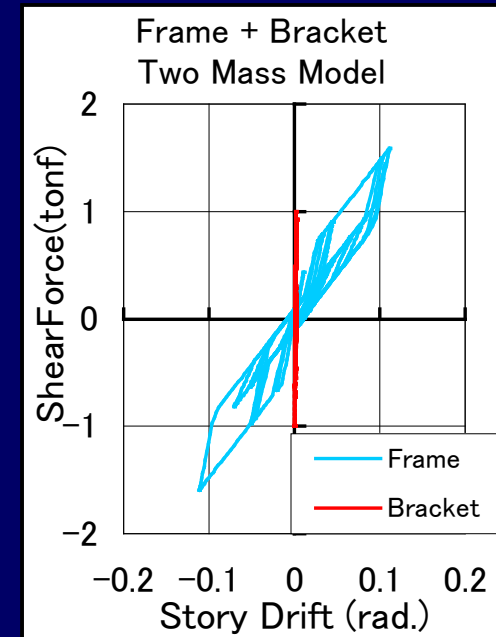
Simulated Effect on Total Structure

- If the stiffness of bracket is too large in comparison with the frame
- Brackets act only as dead load
